SITE ASSESSMENT REPORT
FOR
NORTH SHORE GROUP
CHICAGO, COOK COUNTY, ILLINOIS
TDD: T05-9505-008
PAN: EIL0886SAA

June 14, 1995

UNITED STATES ENVIRONMENTAL PROTECTION AGENCY
Emergency and Enforcement Response Branch
77 West Jackson Boulevard
Chicago, Illinois, 60604

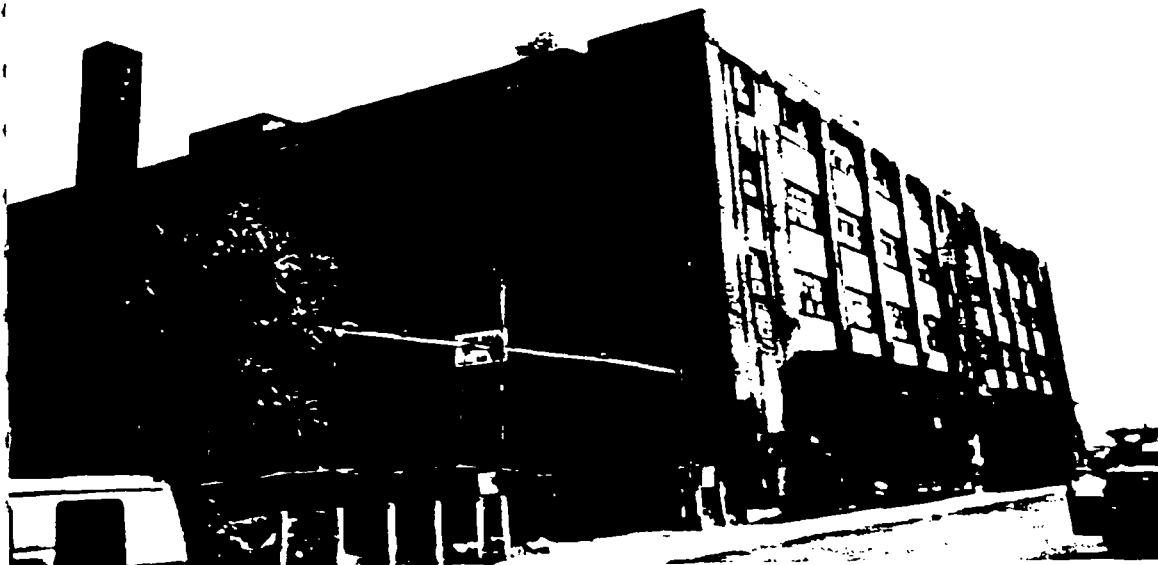
SITE NAME: NORTH SHORE GROUP
 TDD #: T05-9505-008
 DATE: 6-6-95
 TIME: 1030
 DIRECTION: SOUTHEAST
 PHOTOGRAPHER: DAVE HENDREN

CAMERA: DISPOSABLE
 FILM: ASA 400, 24 EXPOSURES
 SUBJECT: BUILDING AND OPEN GATE

The group left the building at 1030 hours to examine the outside of the property. OSC Faryan requested that Holder make arrangements to secure the gate of the property with fencing in order to discourage any additional dumping of chemicals in the building or scavenging of materials. The group observed the exterior of the building, noting that bricks forming the upper facade were loose and collapse of various areas of the upper structure was likely.

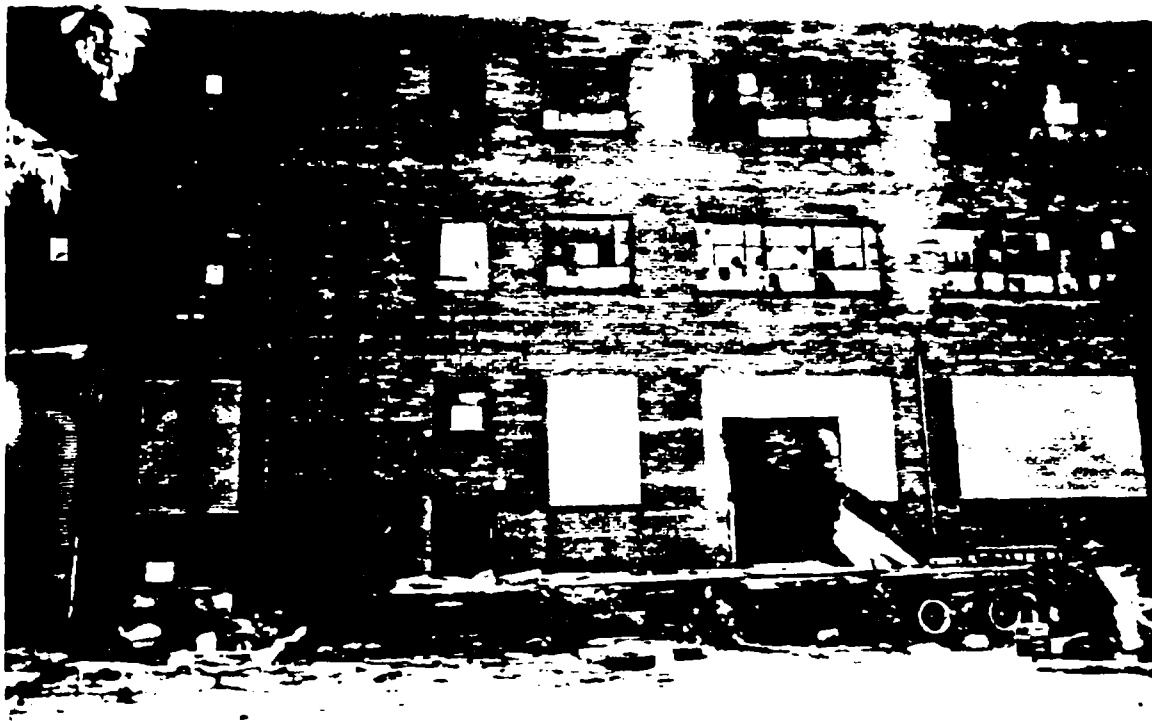
SITE NAME: NORTH SHORE GROUP
 TDD #: T05-9505-008
 DATE: 6-6-95
 TIME: 1040
 DIRECTION: EAST
 PHOTOGRAPHER: DAVE HENDREN

CAMERA: DISPOSABLE
 FILM: ASA 400, 24 EXPOSURES
 SUBJECT: ENTRANCES ON WEST SIDE OF BUILDING

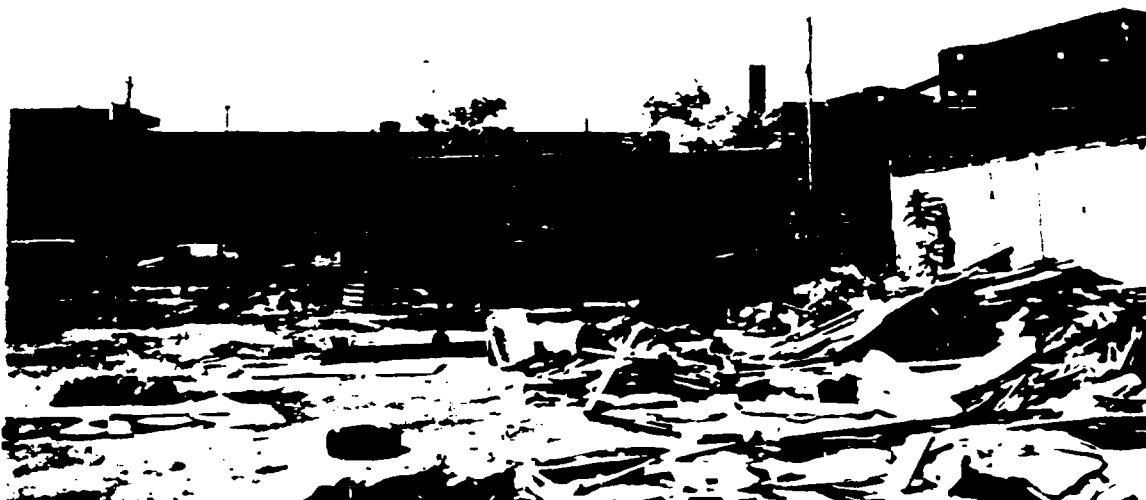
SITE NAME: NORTH SHORE GROUP
 TDD #: T05-9505-008
 DATE: 6-6-95
 TIME: 1045
 DIRECTION: SOUTH
 PHOTOGRAPHER: DAVE HENDREN

CAMERA: DISPOSABLE
 FILM: ASA 400, 24 EXPOSURES
 SUBJECT: VIEW OF YARD

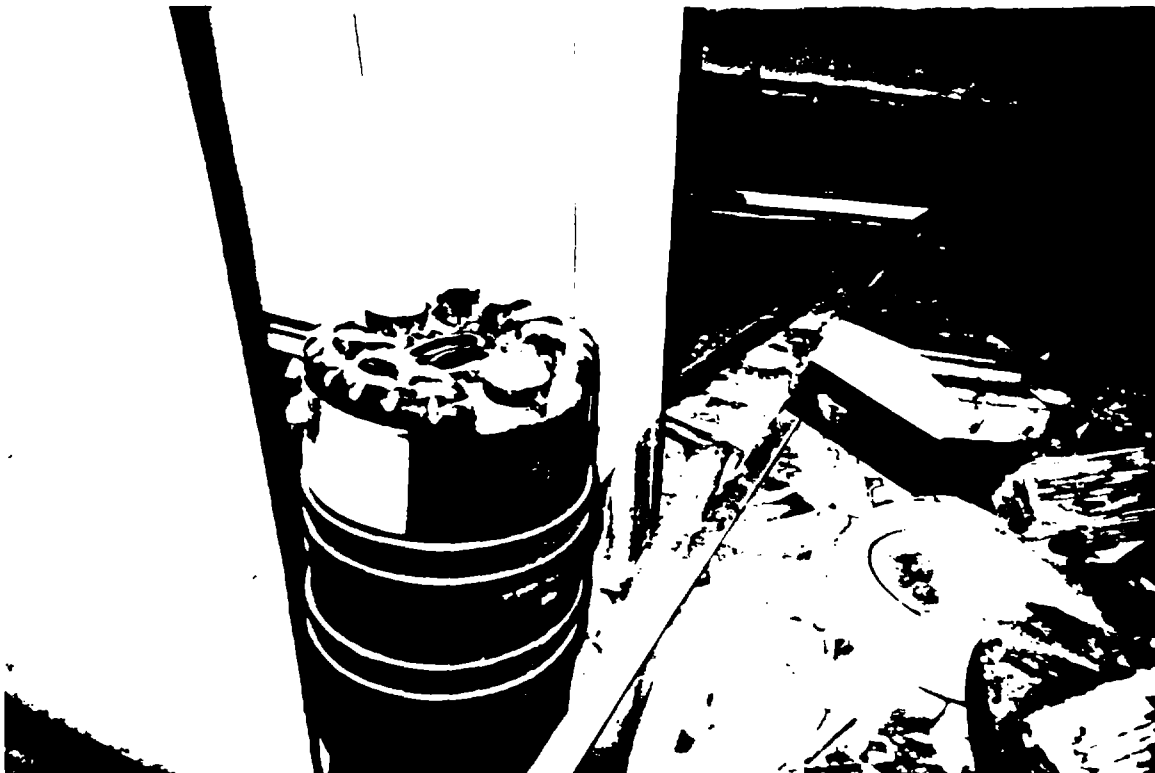
SITE NAME: NORTH SHORE GROUP
 TDD #: T05-9505-008
 DATE: 6-6-95
 TIME: 0940
 DIRECTION: ---
 PHOTOGRAPHER: DAVE HENDREN

CAMERA: DISPOSABLE
 FILM: ASA 400, 24 EXPOSURES
 SUBJECT: POISON CONTAINER

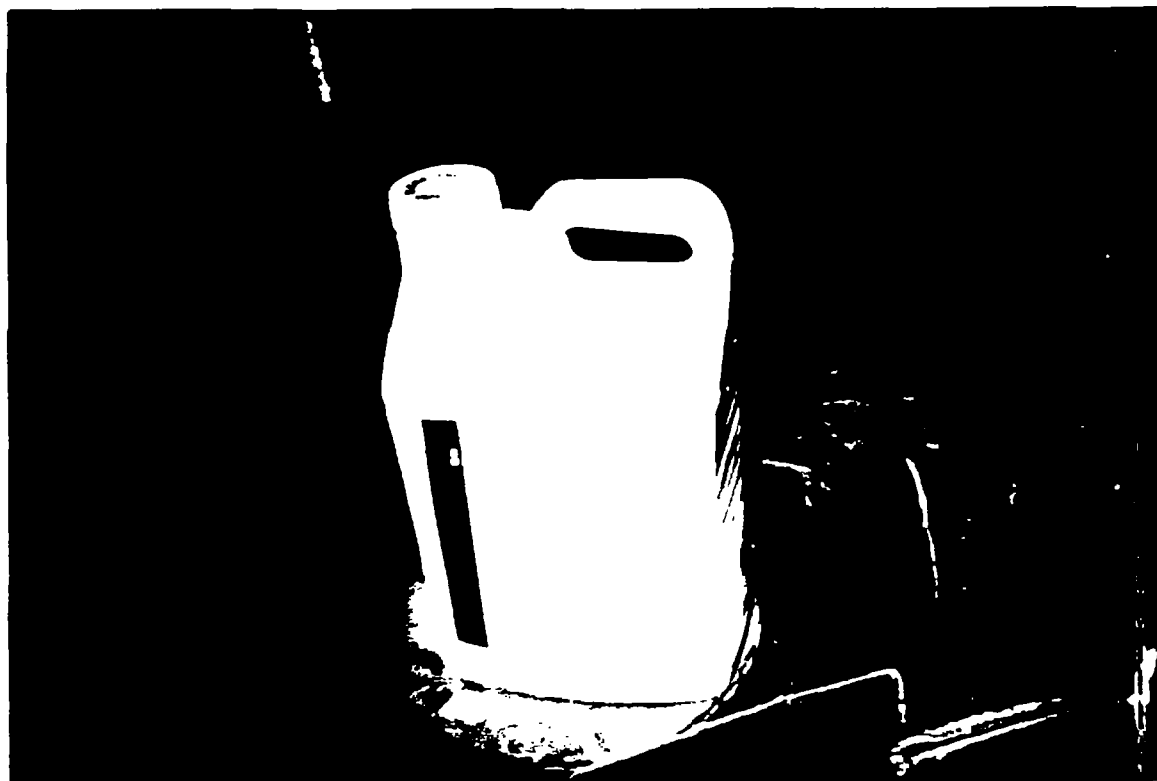
SITE NAME: NORTH SHORE GROUP
 TDD #: T05-9505-008
 DATE: 6-6-95
 TIME: 0945
 DIRECTION: ---
 PHOTOGRAPHER: DAVE HENDREN

CAMERA: DISPOSABLE
 FILM: ASA 400, 24 EXPOSURES
 SUBJECT: CYGON 2-E INSECTICIDE

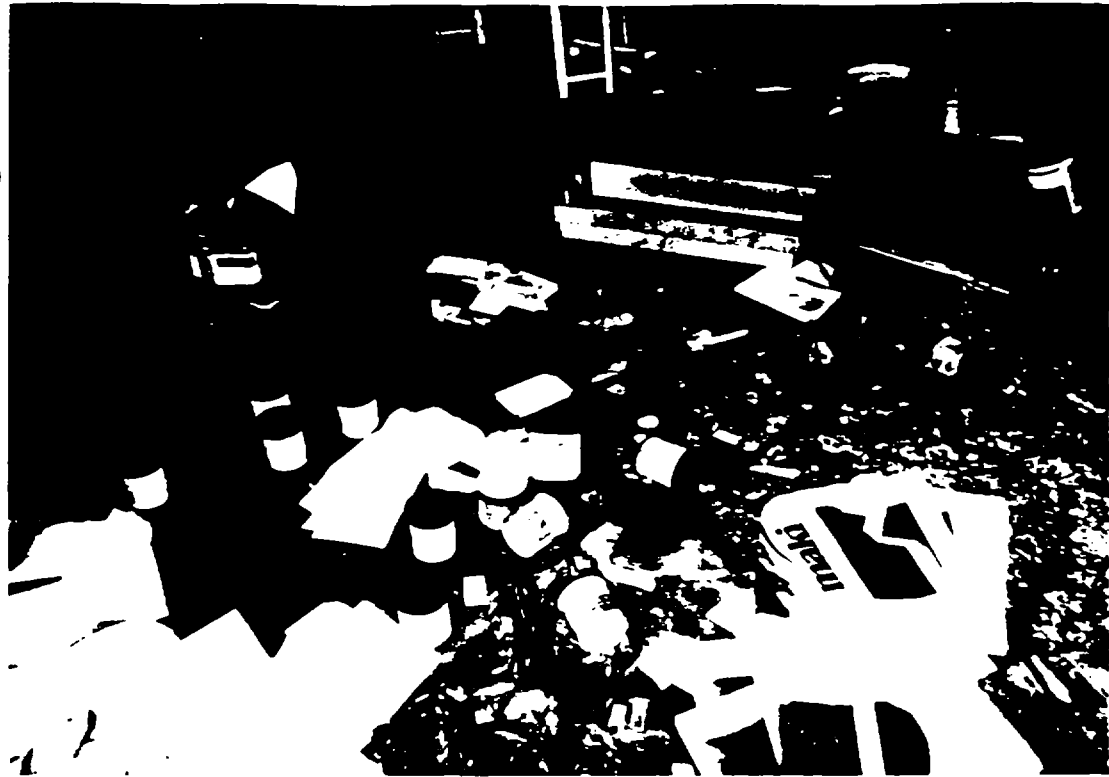
SITE NAME: NORTH SHORE GROUP
 TDD #: T05-9505-008
 DATE: 6-6-95
 TIME: 0940
 DIRECTION: ---
 PHOTOGRAPHER: DAVE HENDREN

CAMERA: DISPOSABLE
 FILM: ASA 400, 24 EXPOSURES
 SUBJECT: JARS WITH KEPONE POWDER

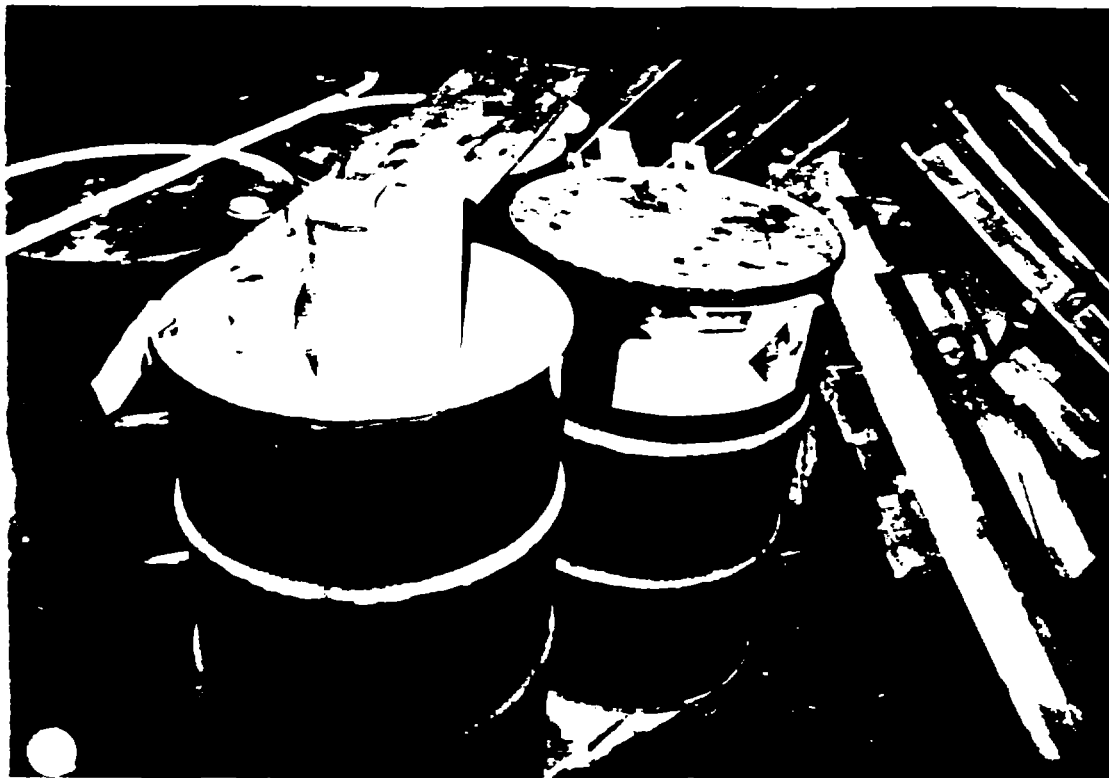
SITE NAME: NORTH SHORE GROUP
 TOD #: TOS-9505-008
 DATE: 6-6-95
 TIME: 0950
 DIRECTION: ---
 PHOTOGRAPHER: DAVE HENDREN

- **Threat of fire or explosion.** Numerous 55-gallon drums containing flammable liquids were observed on the first floor of the building, including; fourteen 55-gallon drums of methyl alcohol, and five 55-gallon drums of isopropyl alcohol. Although these drums appeared in good condition, the contents of the drums could be used as accelerants. Evidence of fires started in the building were present in the basement. The building contained large amounts of ignitable paper and wood products on every floor.

CAMERA: DISPOSABLE
 FILM: ASA 400, 24 EXPOSURES
 SUBJECT: DRUMS WITH ISOPROPYL ALCOHOL
